**New Building Inspection Report - Lockup Stage**

New Building Inspection - Lockup Stage

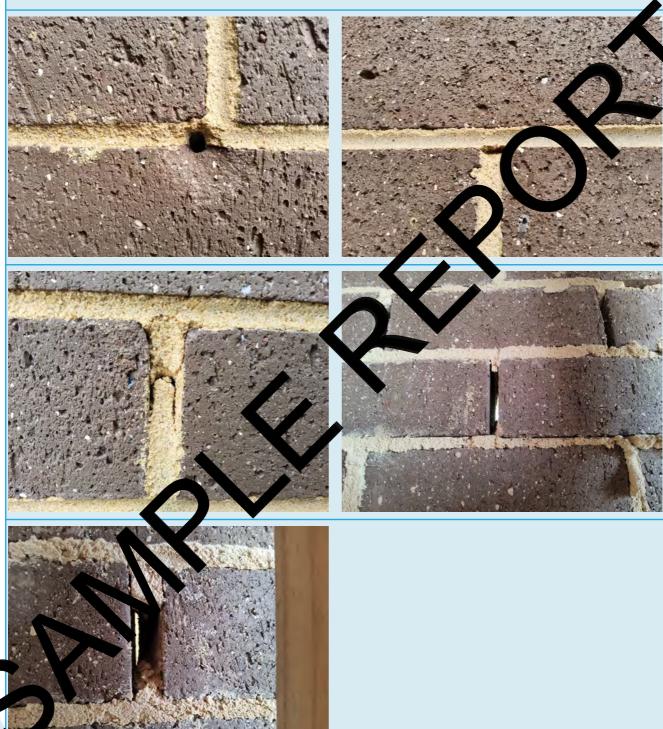
General note, check throughout, it has been observed that there appear to be a number of gaps/holes to the brick mortar that will need to be filled in.

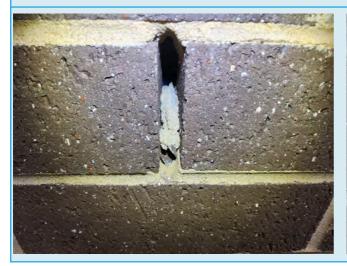
General note, check throughout, it has been observed that there appear to be a number of weep holes that are blocked with mortar that will need to be cleaned out.

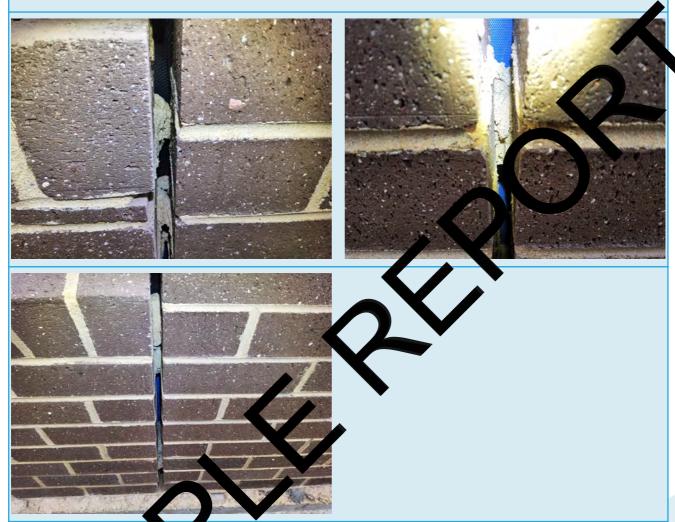
General not, check throughout, it has been observed that there appears to be a build up of mortar in the expansion joints that will need to be cleaned out.

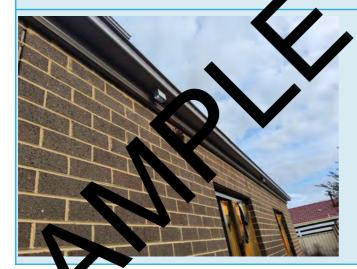
It has been observed that the downpipes were not yet installed at the time of the inspection.

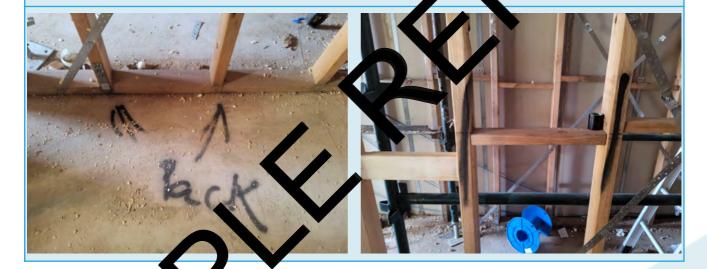
Passage leading to the laundry, left elevation left hand side, it has been observed at the wall requires straightening.

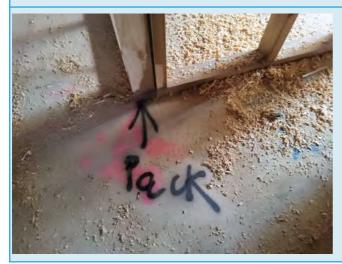
Passage leading to the laundry, rear elevation, it has been observed that the wall requires straightening.

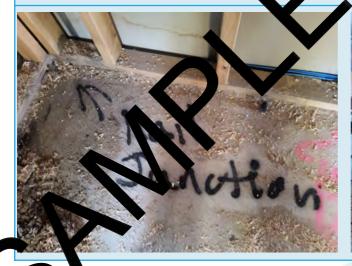
Passage leading to the kitchen, left elevation less hand side, it has been observed that the wall corner junction has not been nailed off.

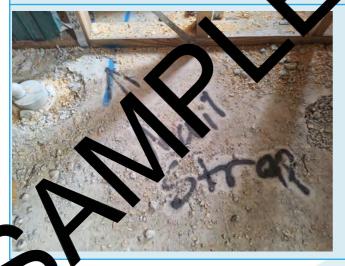
Ensuite, rear elevation, bottom left-hand side at has been observed that the metal hoop iron strap will need to be nailed off

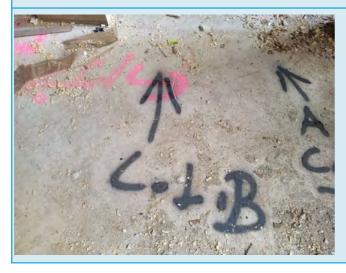
Bedroom 1, rear elevation right-hand side, it has been observed that the cornice line appears to be bowed.

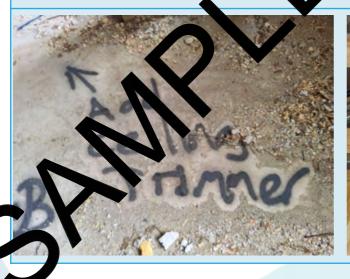
Bedroom 1, rear elevation right hand side, it is been observed that an additional ceiling trimmer will need to be installed to the ceiling.

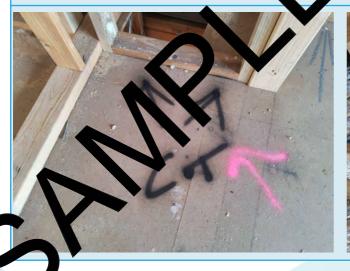
Bedroom 2 robe, right elevation, it has been served that ceiling trimmers will need to be installed.

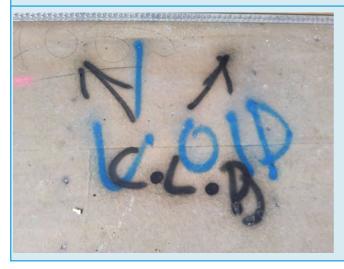
Bedroom 2, left elevation, it has been observed that the cornice line appears to be bowed.

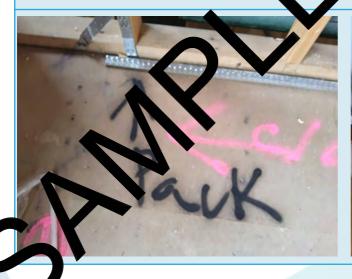
Bedroom 2, left elevation left-hand side, it has been observed that the wall requires straightening.

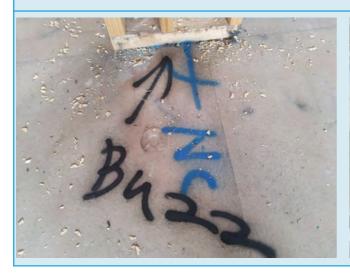
Bedroom 2, rear elevation, it has been observed that the wall requires straightening.

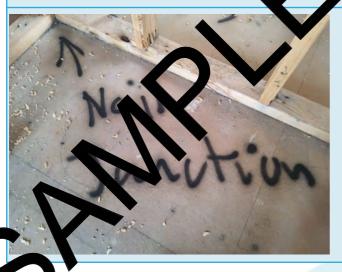
Bedroom 2 robe, left elevation, right hand sign, it has been observed that the corner junction has not been nailed off.

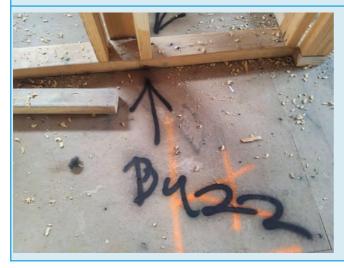
Passage learning to bedroom 2, right elevation, it has been observed that the wall requires straightening.

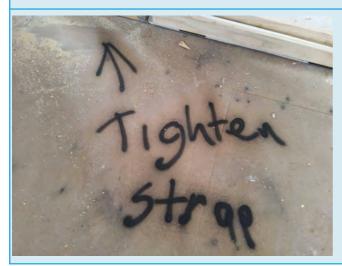
Bedroom 4, front elevation left-hand side, it has been observed that the metal hoop iron strap appears to be loose and will need to be tightened.

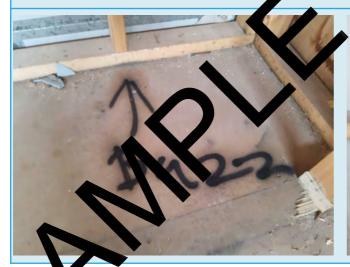
Bedroom 4, left elevation right hand side, it has been observed the the wall requires straightening.

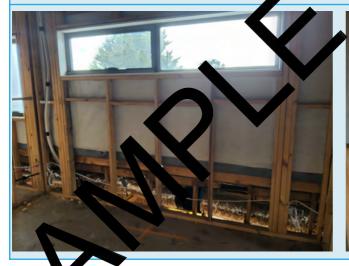
It has been observed that the wall insulation was not yet fully concleted at the time of the inspection.
